**EVALUATION OF THE IMPACT OF OPERATING TEMPERATURE TO  
CORROSION RATE FOR (CUI)**

Dissertation submitted in partial fulfilment of the requirements for the  
Bachelor of Engineering (Hons) (Mechanical Engineering)

Universiti Teknologi PETRONAS

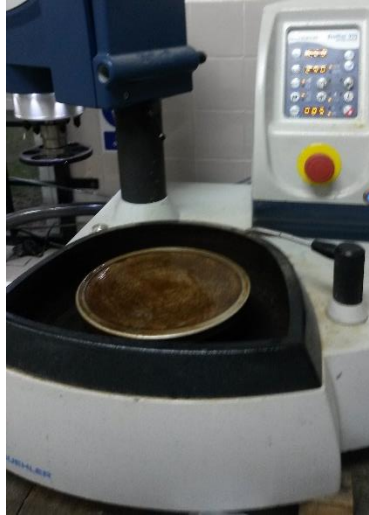
***Figure 6: Grinding machine for ring specimens***

Figure 6 shows that the grinding machine that have been used to resurface the ring specimens. Grinding paper that used are from the range of grit 120, 240/P280, 320/P400, and 600 grade.

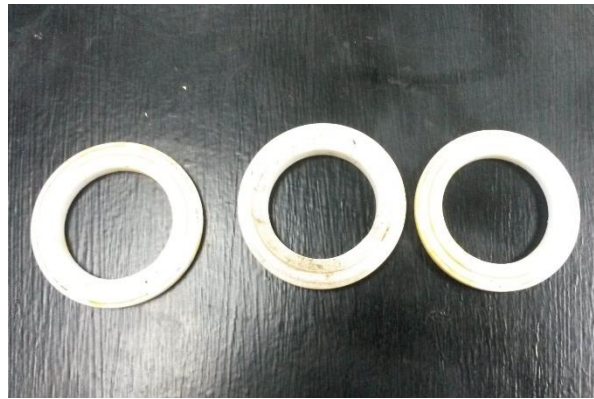
This cell consisted of six ring specimens which were separated by non -conductive spacers. The insulation material as shown in the figure 8 used for the spacers was a polytetrafluoroethylene resin.

*Figure 8: Non-conductive spacers*

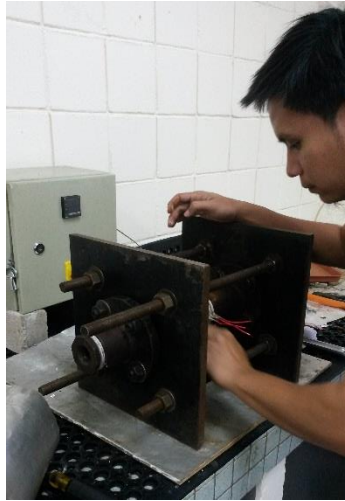
The testing section which included alternate rings of insulation and pipe material was held together by two blind flanged pipe sections on both ends of the CUI setup as shown in figure 10. Three pipe clamps were used to hold the cell set-up together. The test temperature at the ring surfaces were achieved via an immersion heater incorporated to the inside of the pipe section which was filled with a thermal conductive silicone oil, in order to be the liquid medium inside the carbon steel pipe.

*Figure 9: Ring specimens' setup at CUI -cell*

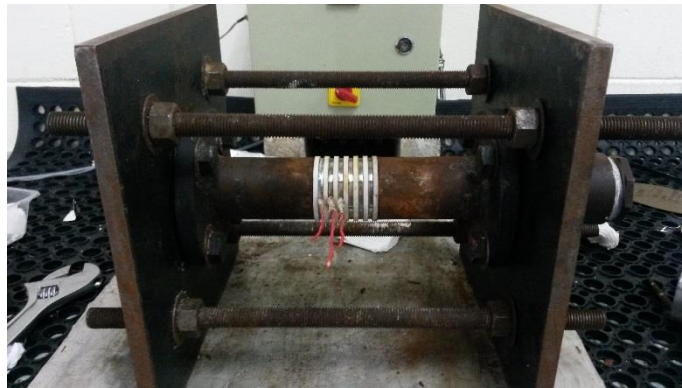
*Figure 10: Complete setup for ring specimens*

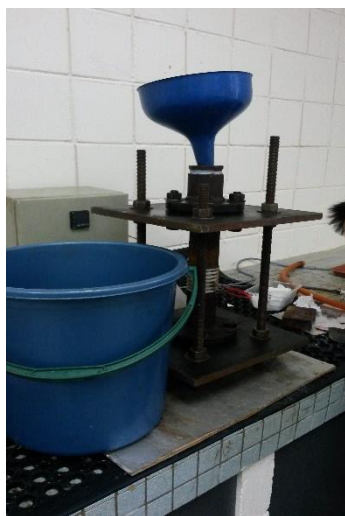
*Figure 11: Silicon oil injection process*

Figure 11 shows the procedure to put an amount of silicon oil inside the carbon steel pipe. The function for that particular oil is to become a medium inside the pipe, as well as to transfer the heat inside, similar to the actual oil transported pipeline in industries.

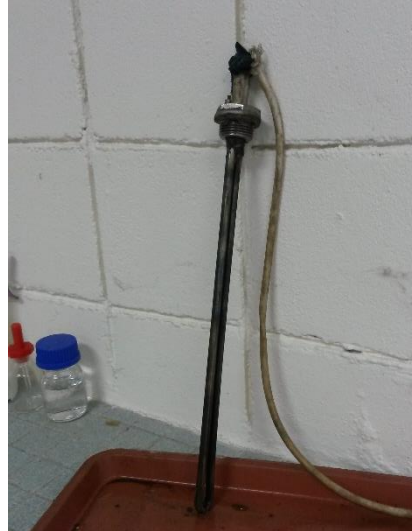
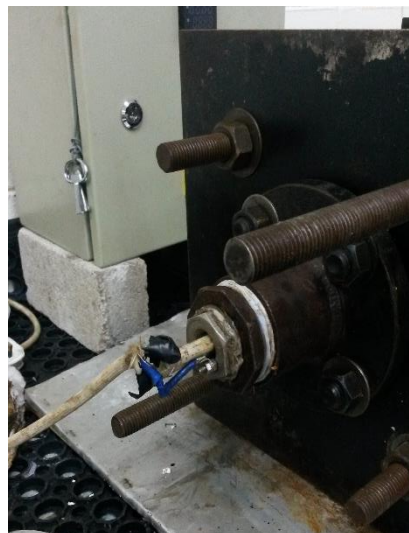
***Figure 12: Immersion heater***

Figure 12 and figure 13 shows the immersion heater procedure in order to setting up the CUI –Cell. This heater is important to set the desired operating temperature at the ring surfaces.

***Figure 13: Complete setup for immersion heater***

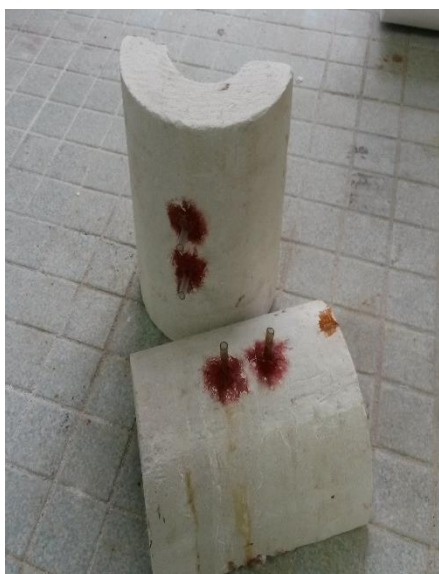
A block of thermal insulation placed above the testing section provided the annular space to retain test environment. The insulation used was a water resistant moulded perlite type with a low concentration of chloride (35-40 ppm), and also rockwool insulation as shown in figure 14 and figure 15. The test environment selected was an aqueous solution containing 0.5g (NaCl), 5L of reagent water with pH adjusted to 6 (with H<sub>2</sub>SO<sub>4</sub>) in order to simulate atmospheric condensate as shown in figure 16. One half of the outer surfaces of the ring specimens were exposed to the test environment during the testing. Other than that, figure 17 shows test solution was pumped into the annular space between the thermal insulation and the outer surfaces of the ring specimens through two ports. The ring specimens were used as test electrodes in three separate electrode cells. The centre ring was used for the working electrode (WE) while the other two rings were used as the auxiliary electrode (AE) and the reference electrode (RE), related to figure 18.

***Figure 15: Perlite Insulation***

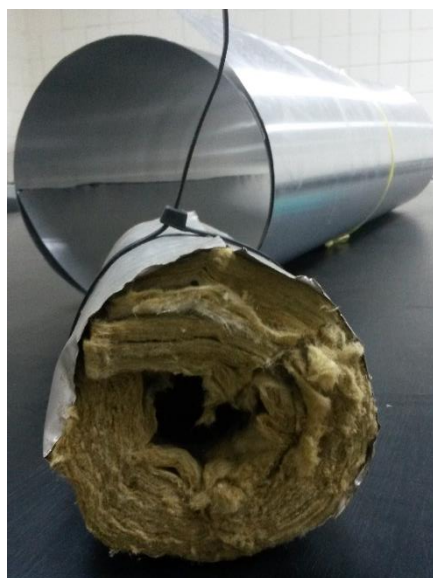
***Figure 14: Rockwool Insulation***

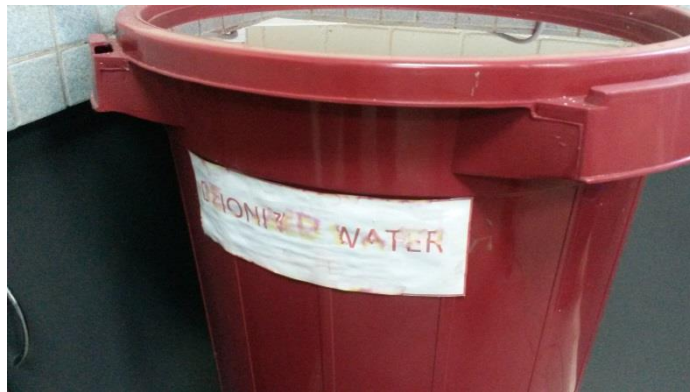
*Figure 16: Deionized Solution*

The test environment used for this phase is similar to ASTM G189-07 which is the solution used consist of 100 ppm NaCl dissolved in reagent water, acidified with addition of H<sub>2</sub>SO<sub>4</sub> to pH 6 ( $\pm 0.1$  pH unit) at 24°C. This solution is designed to represent an atmospheric condensate with impurities of chlorides and acids found in industrial and coastal environments.

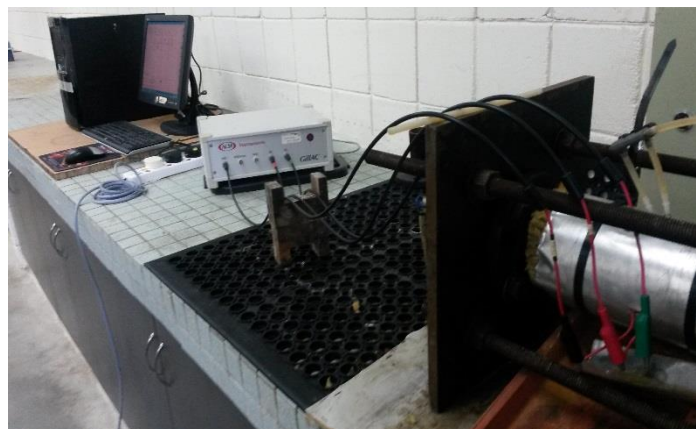
*Figure 18: Complete CUI –Cell setup*

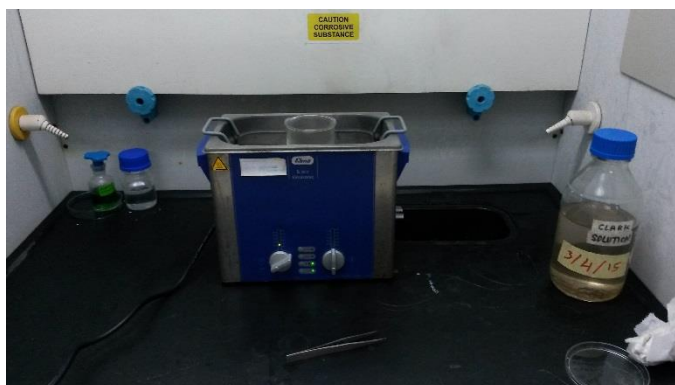
*Figure 19: Ultrasonic Bath for Mass Loss Test*

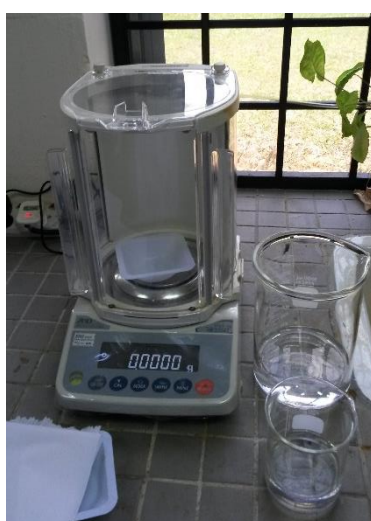
*Figure 20: Mass Loss procedure*
